Investigation of Deterioration of Joints in Concrete Pavements

National Concrete Pavement
Technology Center

Final Report
August 2012

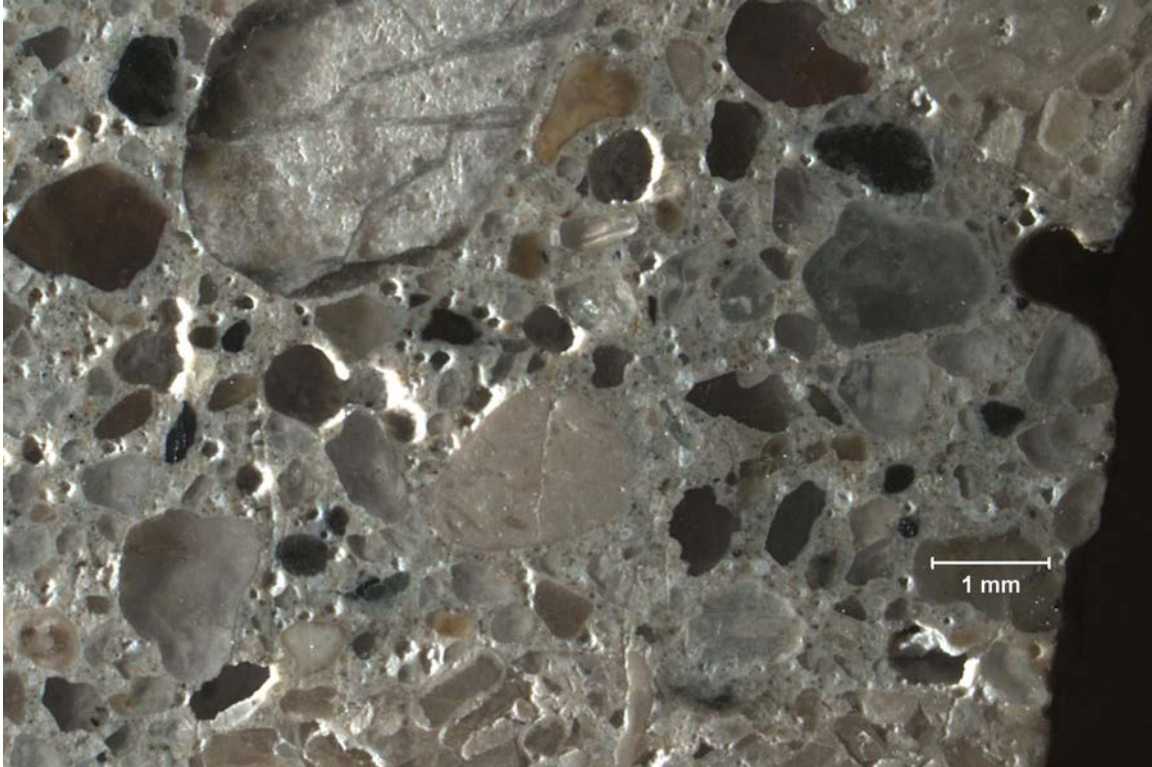
PHOTO: 15

1. The cause of the distress observed in core "D" was cyclic freeze/thaw action on saturated concrete which originally contained an entrained air void system of good quality. The air void system has been compromised by secondary crystalline fillings. Excessive secondary ettringite deposition has filled many of the smallest air voids in the paste adjacent to the joint and created "non-durable" concrete.

SAMPLE ID: D **DESCRIPTION:** The great majority of fine spherical entrained air voidspaces at 60mm depth in the core and directly adjacent to the distressed joint (left) are filled with secondary ettringite.
MAG: 15x

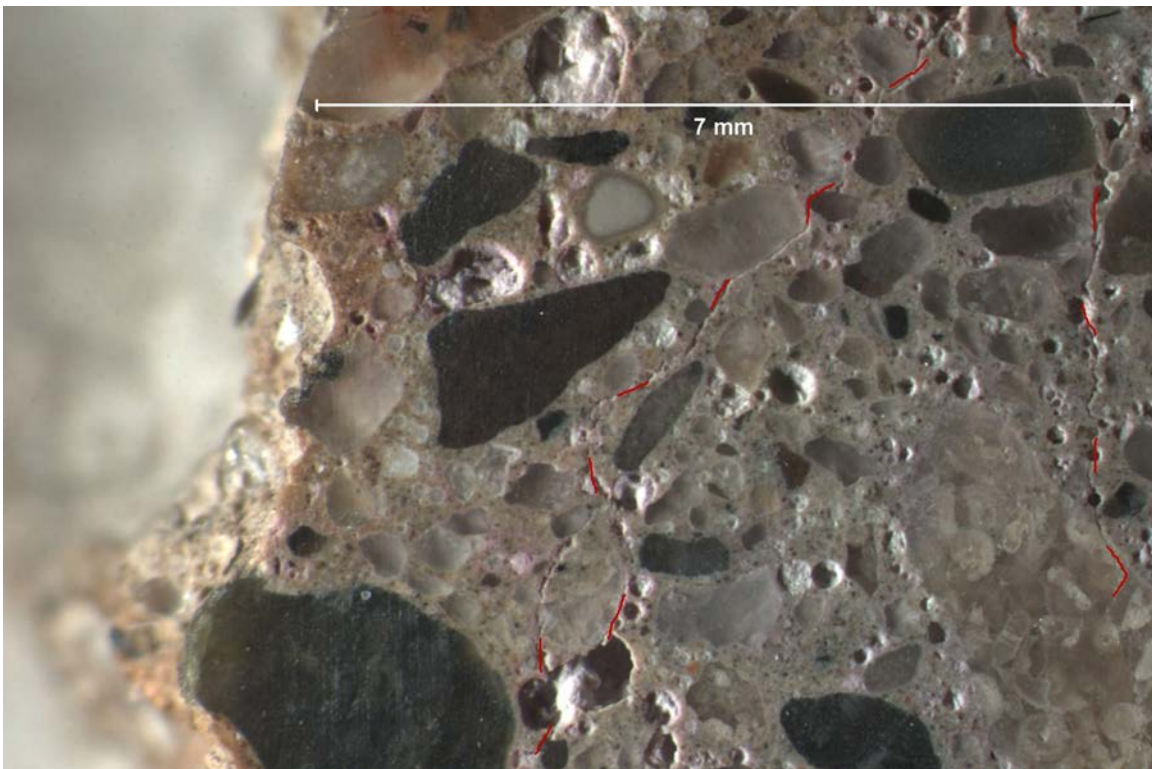
PHOTO: 16

SAMPLE ID: D **DESCRIPTION:** The great majority of fine spherical entrained air voidspaces at 98mm depth in the core and directly adjacent to the distressed joint (left) are filled with secondary ettringite. Microcracking, oriented sub-parallel to the distressed joint plane, is marked in red dashed line.
MAG: 15x

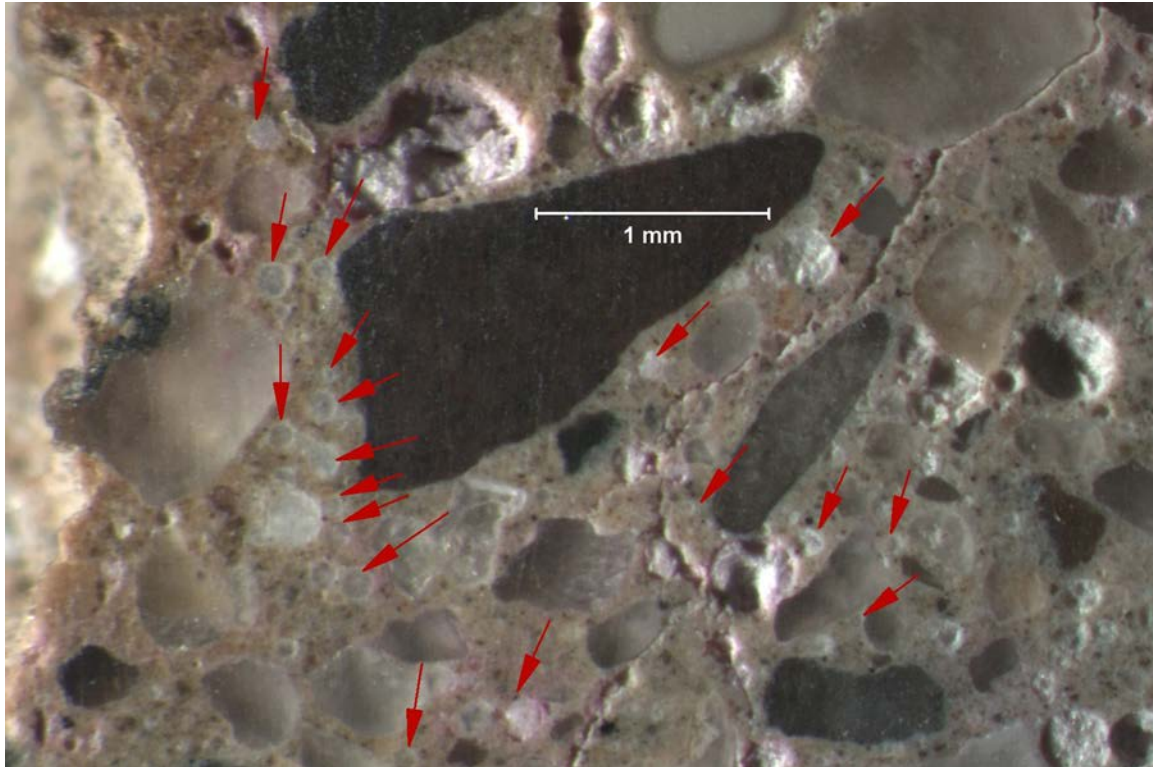
PHOTO: 17

SAMPLE ID: D **DESCRIPTION:** The great majority of fine spherical entrained air voidspaces at 98mm depth in the core and directly adjacent to the distressed joint (left) are filled with secondary ettringite.
MAG: 30x

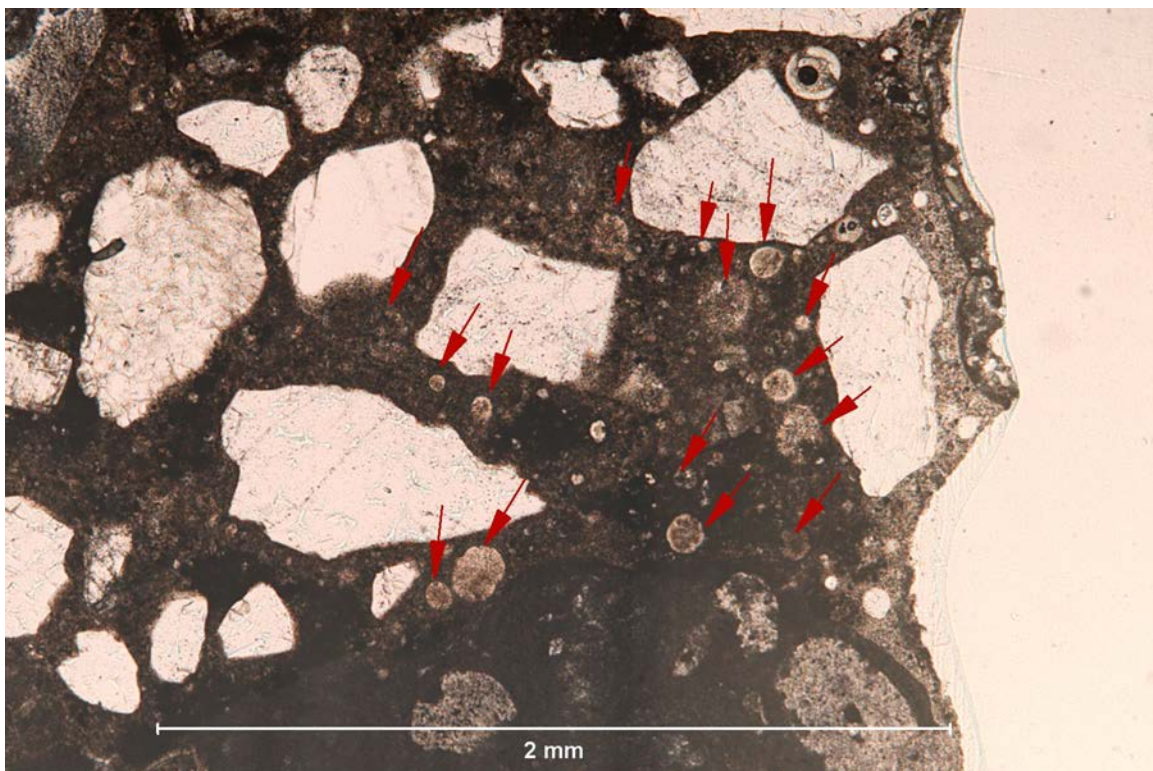
PHOTO: 18

SAMPLE ID: D **DESCRIPTION:** Fine spherical entrained air voidspaces at depth in the core, and directly adjacent to the distressed joint (right) are filled with secondary ettringite; in thin section under plane polarized light.
MAG: 40x

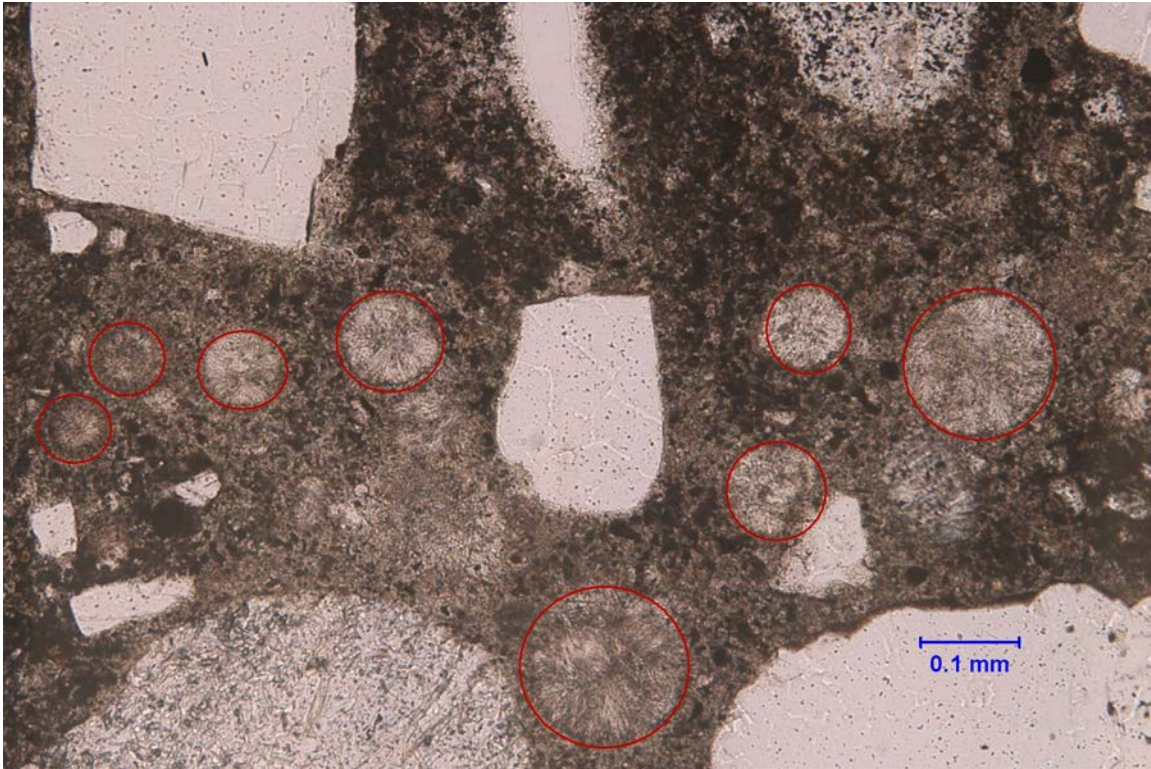
PHOTO: 19

SAMPLE ID: D **DESCRIPTION:** The great majority of fine spherical entrained air voidspaces at depth in the core and directly adjacent to the distressed joint, are filled with secondary ettringite.

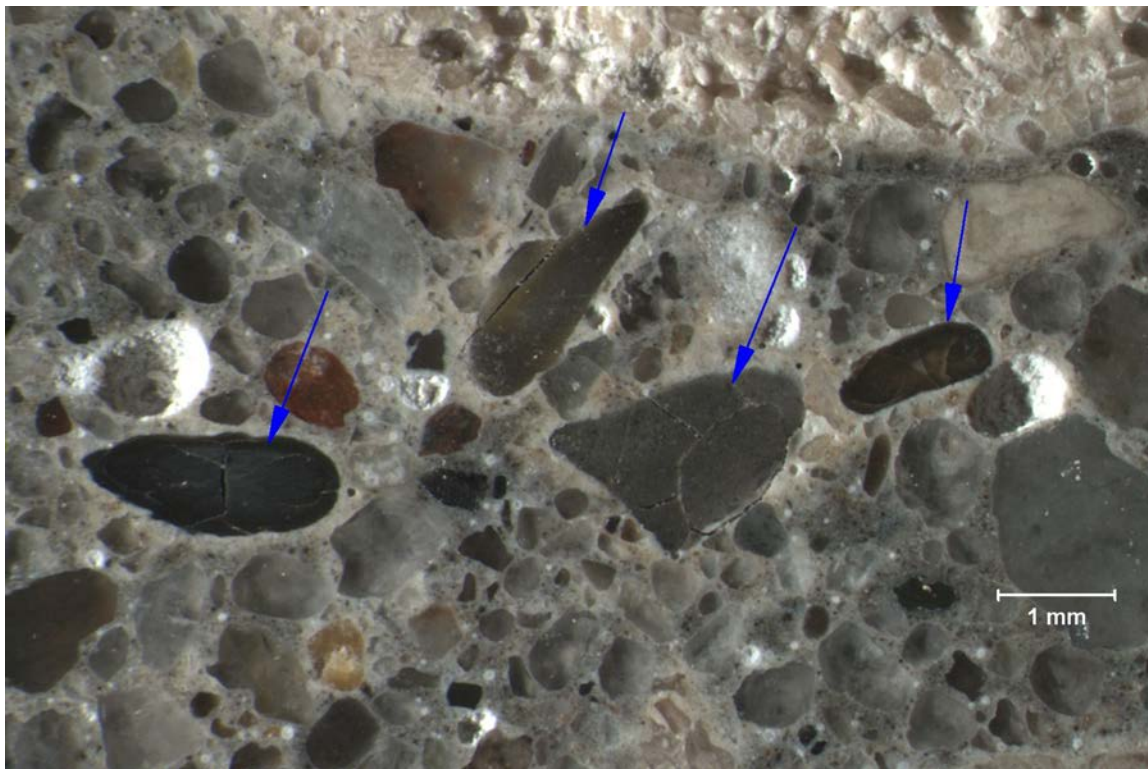
PHOTO: 25

2. In general, the coarse aggregate was hard and durable. However, some coarse aggregate particles at depth in the joint in core "D" appear to exhibit susceptibility to cyclic freeze-thaw action while saturated. Microcracking, which appears to concentrate within in the coarse aggregate, occurs at below the sawcut joint to 100mm depth in mostly sub-vertical orientations and in mostly sub-horizontal orientations at below 100mm depth. A single coarse aggregate, intersected by the joint crack in core "P1", exhibits concentrated sub-vertical microcracking. The particles appear relatively porous. Significant amounts of highly alkali-silica reactive (ASR) fine shale aggregate particles were observed scattered in both core samples. The reactive shales are not a source of distress.

SAMPLE ID: P1 **DESCRIPTION:** Abundant reactive shale particles at depth in the core.

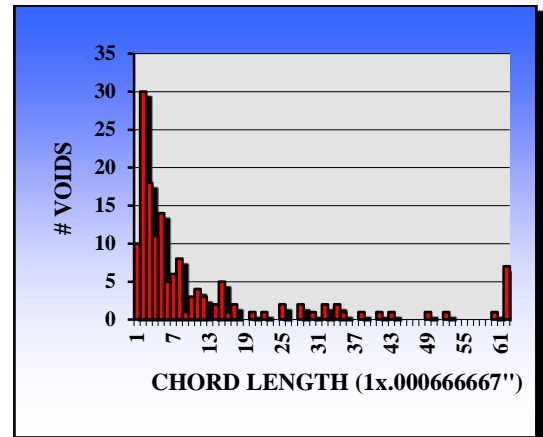
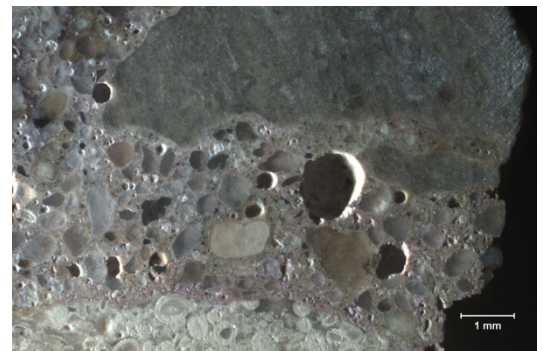
Air Void Content %	3.3
Entrained, % < 0.040"(1mm)	1.9
Entrapped, % > 0.040"(1mm)	1.4
Air Voids/inch	3.3
Specific Surface, in ² /in ³	400
Spacing Factor, inches	0.012
Paste Content, % estimated	16.4
Magnification	75x
Traverse Length, inches	45
Test Date	5/24/12

Description: Air void system at joint 140mm depth.

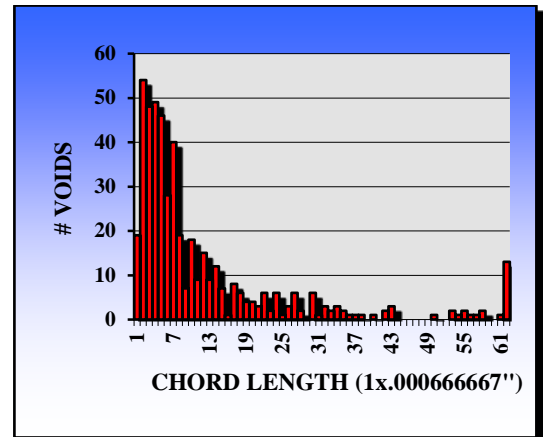
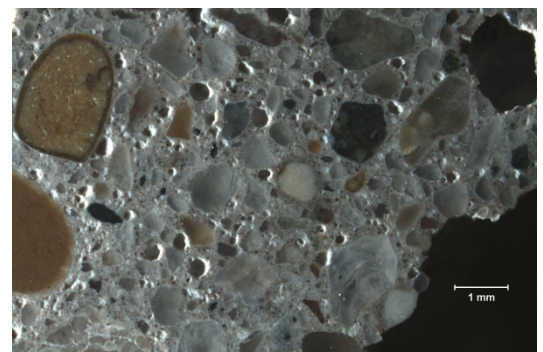
Air Void Content %	4.5
Entrained, % < 0.040”(1mm)	3.3
Entrapped, % > 0.040”(1mm)	1.2
Air Voids/inch	4.9
Specific Surface, in ² /in ³	440
Spacing Factor, inches	0.011
Paste Content, % estimated	26
Magnification	75x
Traverse Length, inches	99
Test Date	5/24/12

Description: Air void system at joint at 55mm depth..

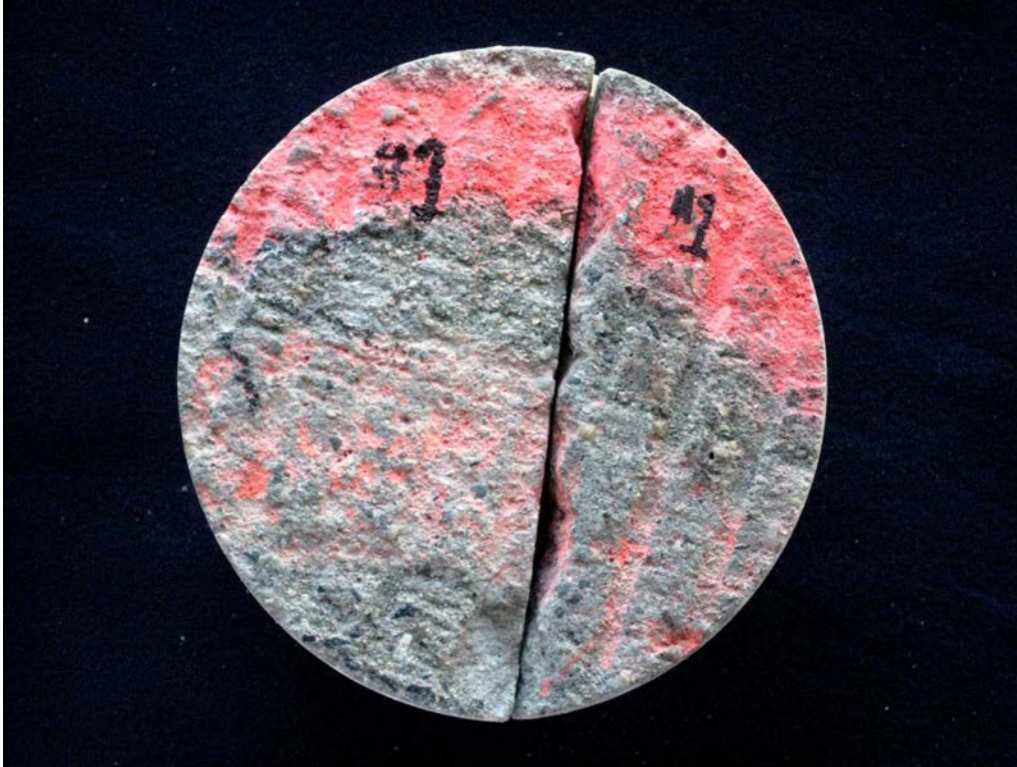
PHOTO: 3

SAMPLE ID: #1 **DESCRIPTION:** Top surface of the core sample, taken directly through a joint, as received.

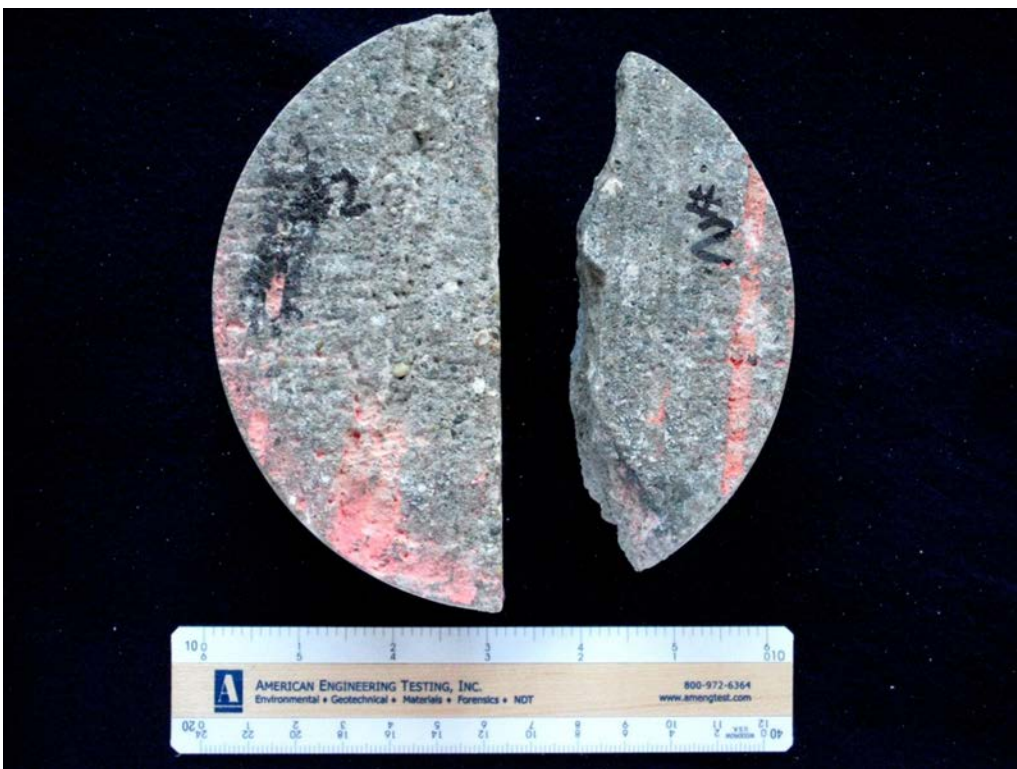
PHOTO: 4

SAMPLE ID: #2 **DESCRIPTION:** The top surface of the core sample, taken directly through a joint, as received.

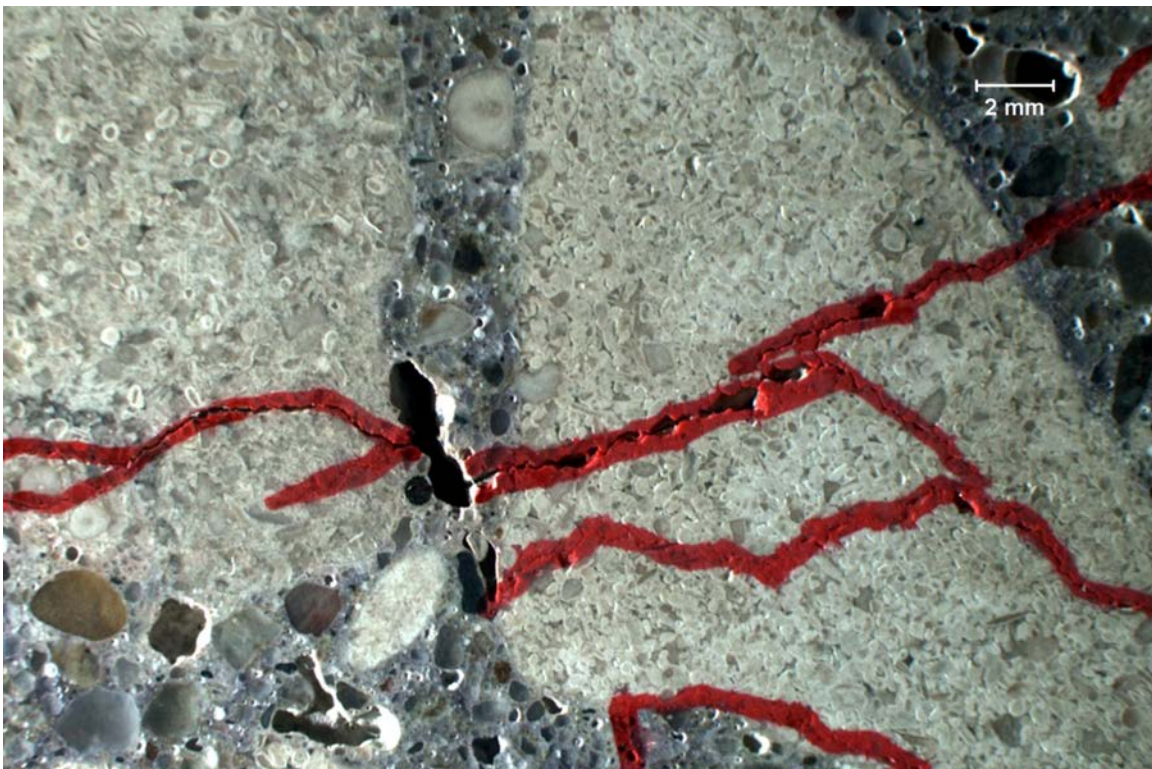
PHOTO: 10

SAMPLE ID: #1 **DESCRIPTION:** Microcracking, proceeding through coarse aggregates at depth in the core, is mapped in red ink.
MAG: 5x

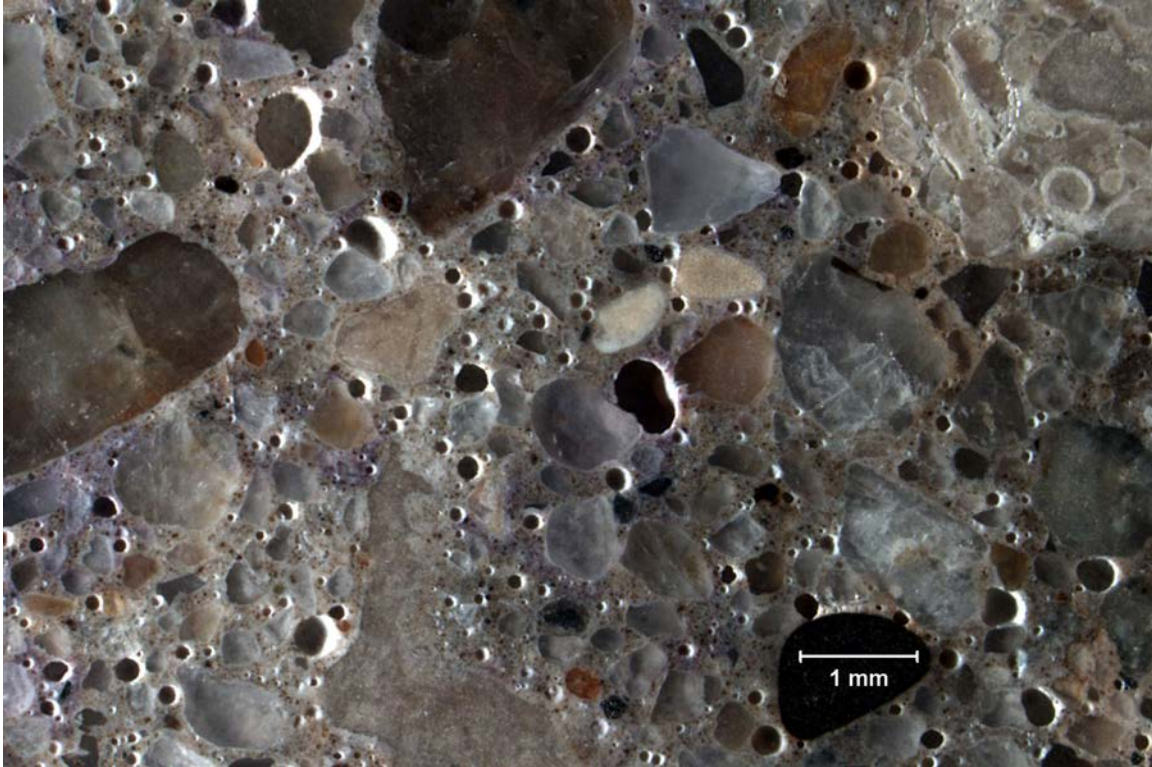
PHOTO: 11

SAMPLE ID: #1 **DESCRIPTION:** Overall hardened air void content proximate to the top surface.

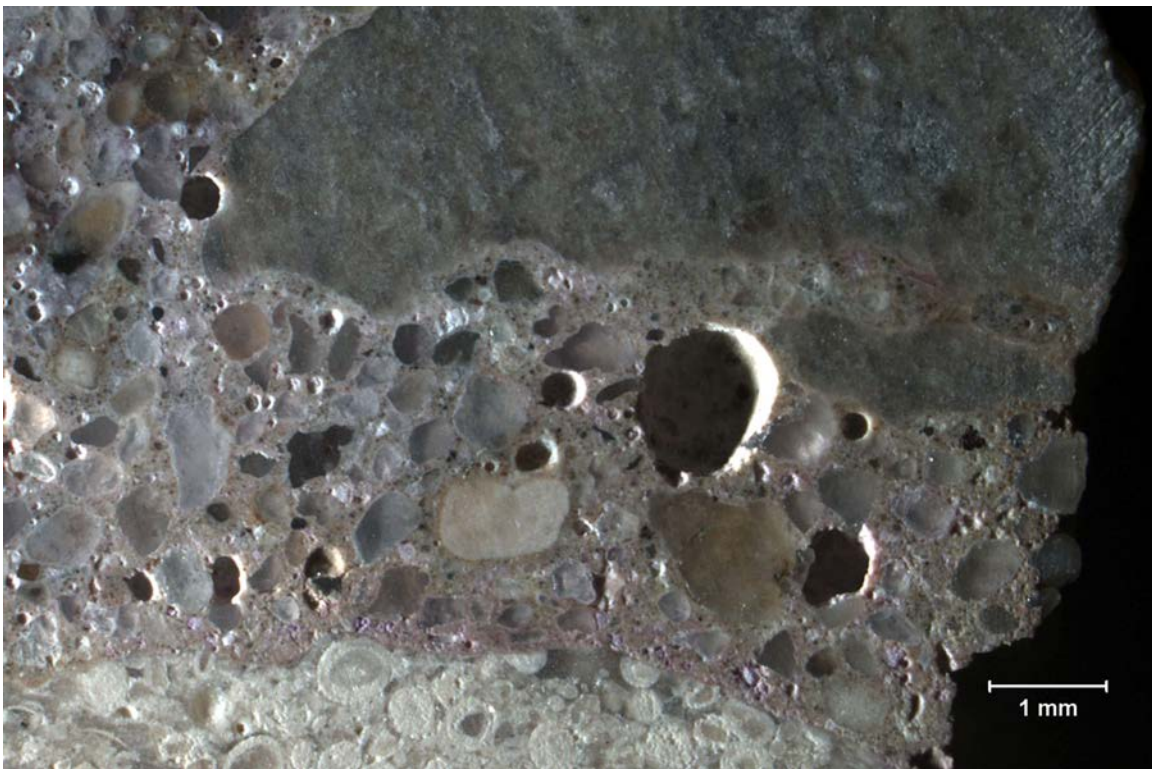
PHOTO: 12

SAMPLE ID: #1 **DESCRIPTION:** Much of the air voids proximate to the joint and at 140mm depth from the top surface are filled with secondary ettringite.

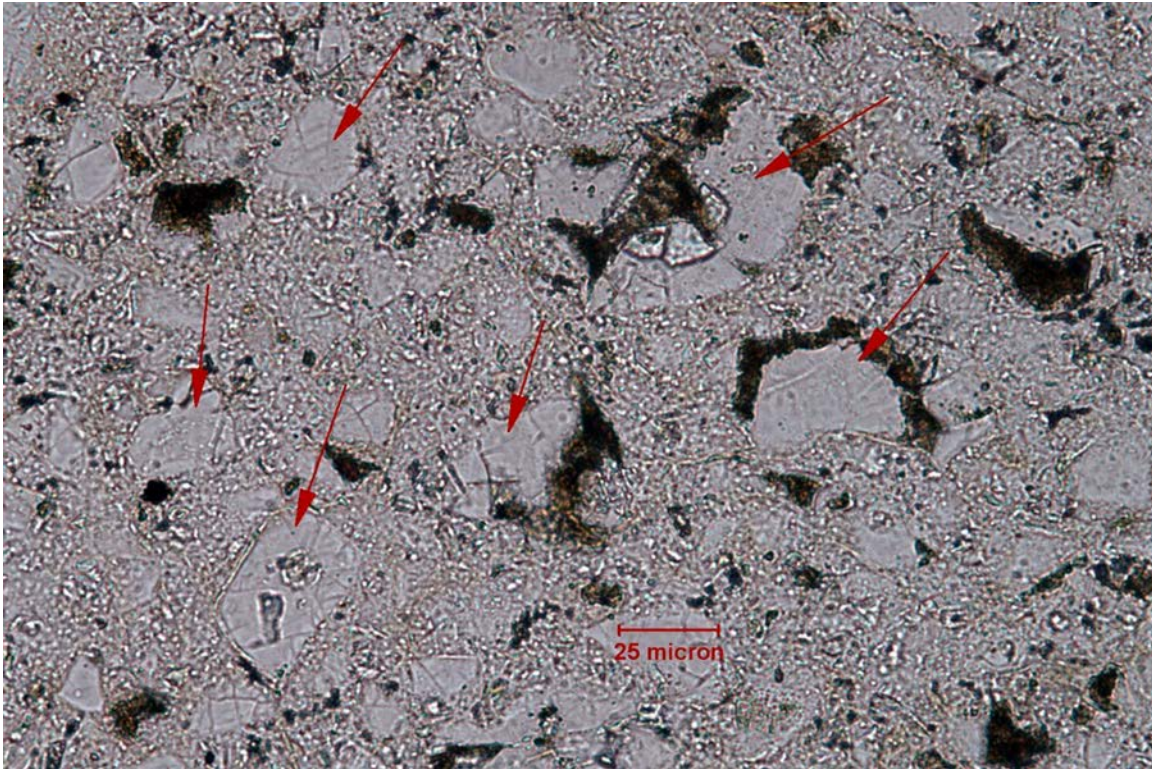
PHOTO: 15

SAMPLE ID: #1 **DESCRIPTION:** Well to fully hydrated alite portland cement clinker particles in thin section of concrete paste under plane polarized light.
MAG: 400x

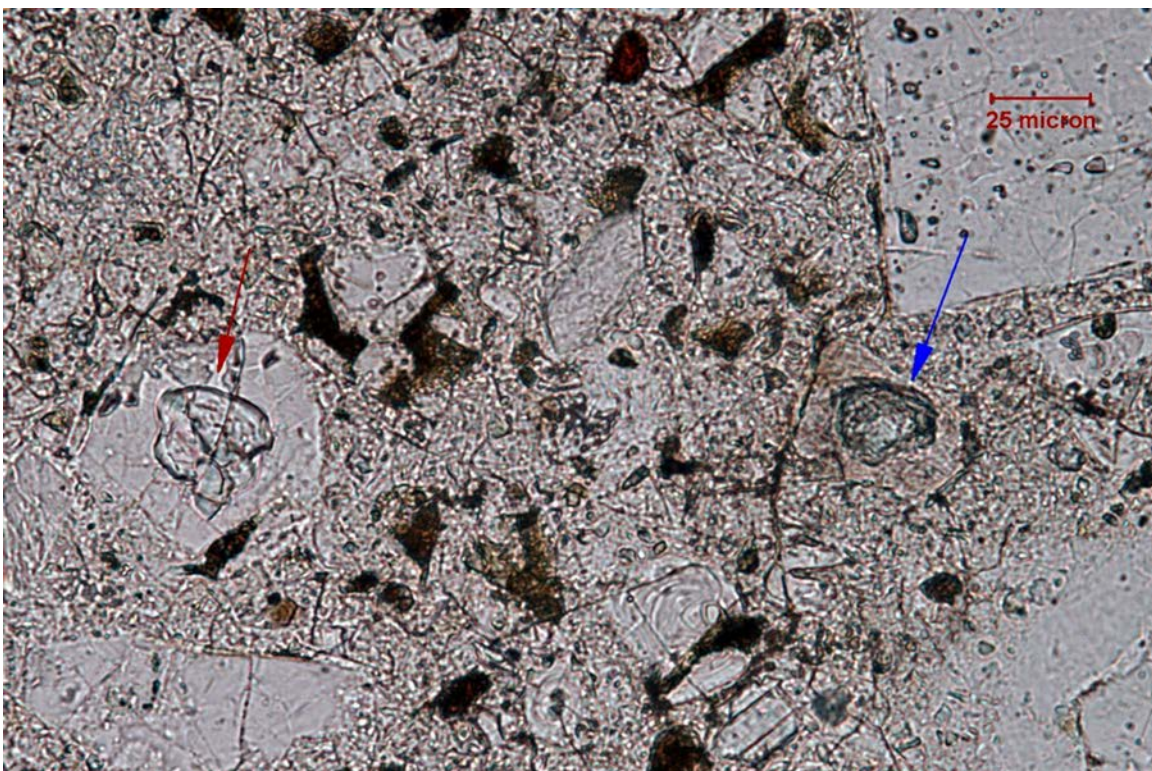
PHOTO: 16

SAMPLE ID: #2 **DESCRIPTION:** Well hydrated alite (red arrow) and well hydrated belite (blue) portland cement clinker particle in thin section of concrete paste under plane polarized light.
MAG: 400x

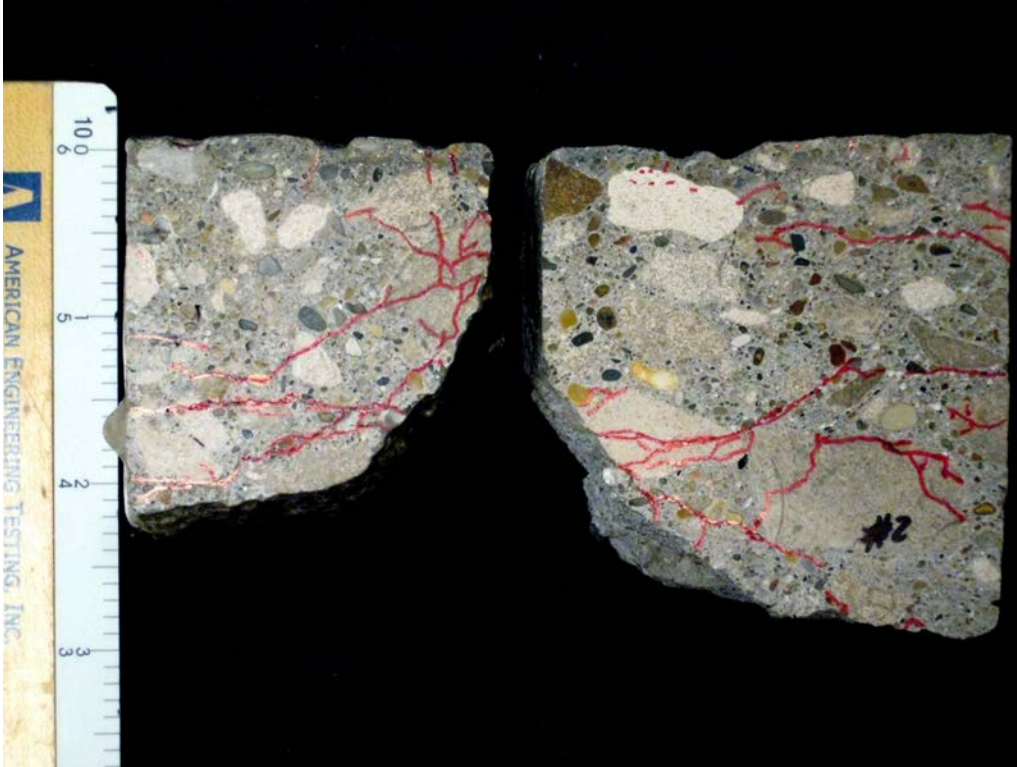
PHOTO: 17

SAMPLE ID: #2 **DESCRIPTION:** Sawcut and lapped cross section of core taken through a distressed joint. Microcracking is mapped in red ink. Note some concentration within coarse aggregate particles.

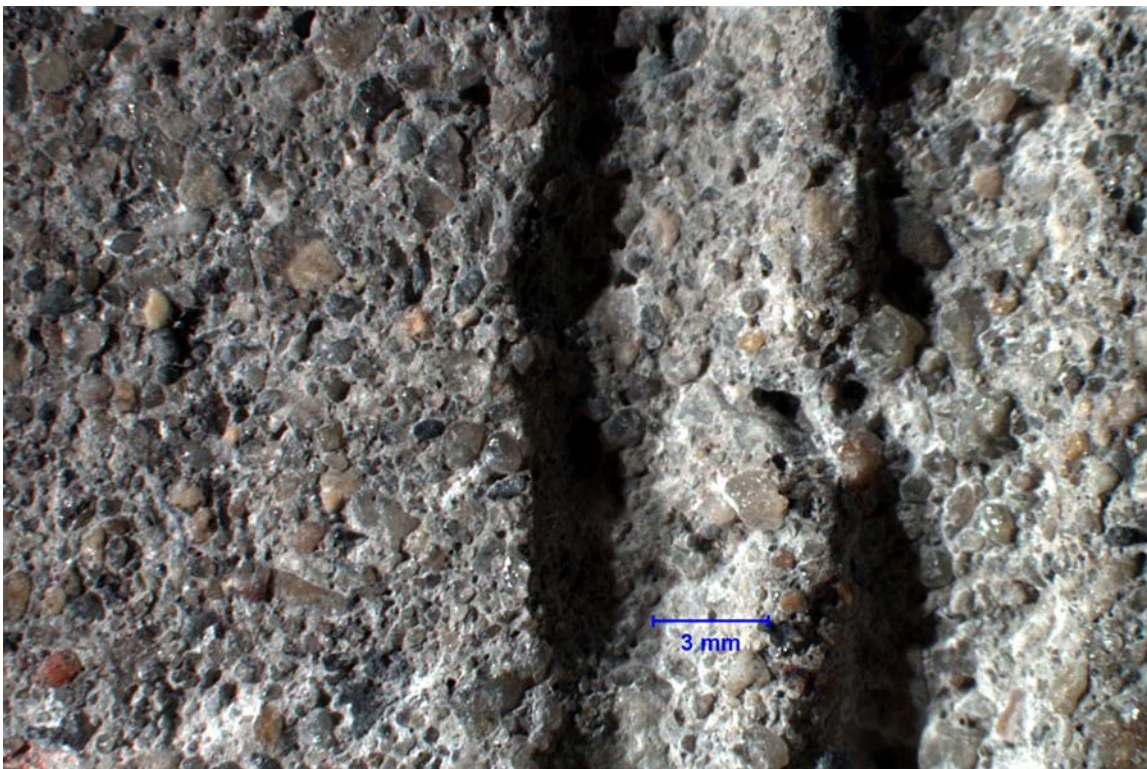
PHOTO: 18

SAMPLE ID: #2 **DESCRIPTION:** The top surface of the core has undergone moderate mortar erosion exposing many fine aggregates.

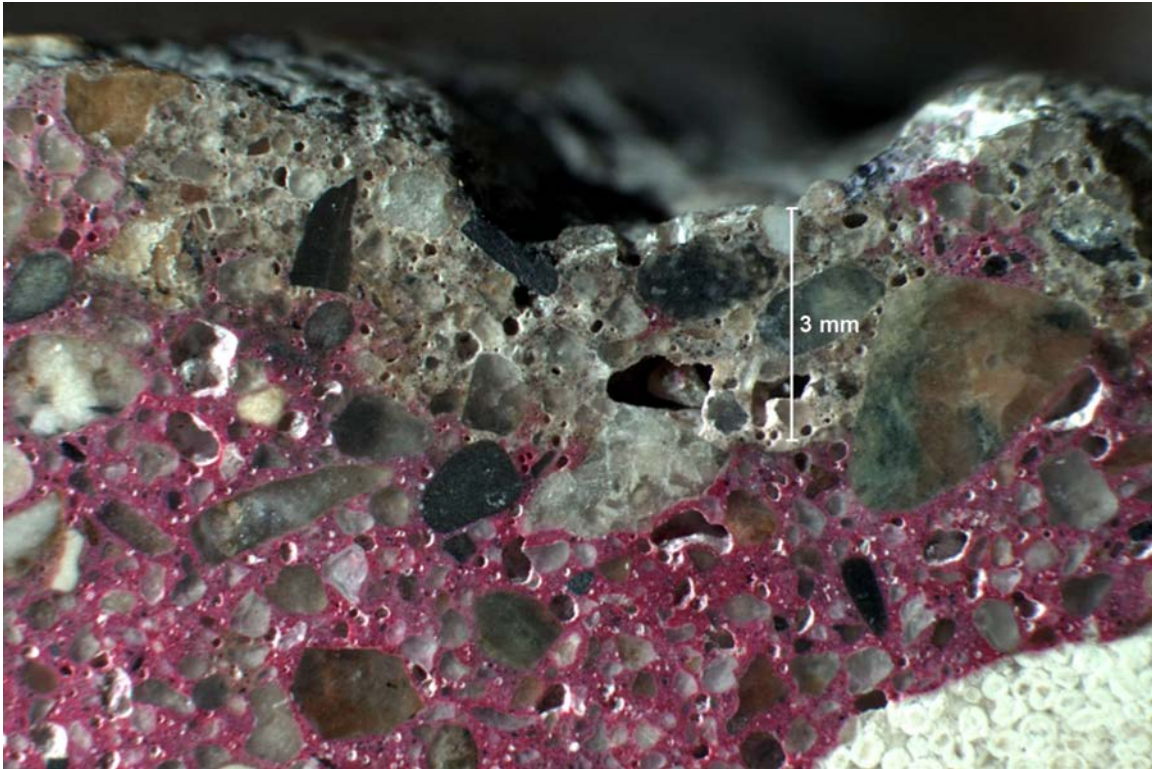
PHOTO: 19

SAMPLE ID: #2 **DESCRIPTION:** Carbonation (unstained paste) ranges from negligible to 3mm depth from the top surface of the core. In freshly sawcut and lapped cross section of core exposed to phenolphthalein pH indicator.

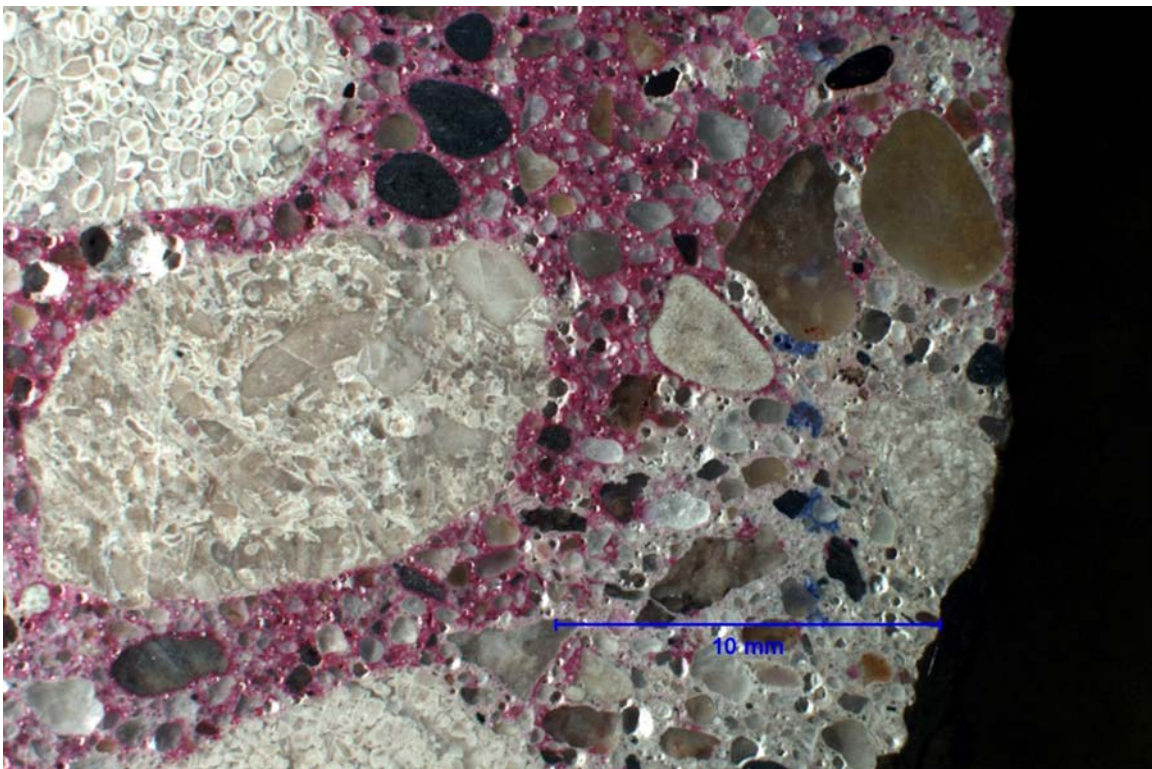
PHOTO: 20

SAMPLE ID: #2 **DESCRIPTION:** Carbonation (unstained paste) ranges from negligible to 10mm depth from the sawcut and distressed joint surface of the core (R).

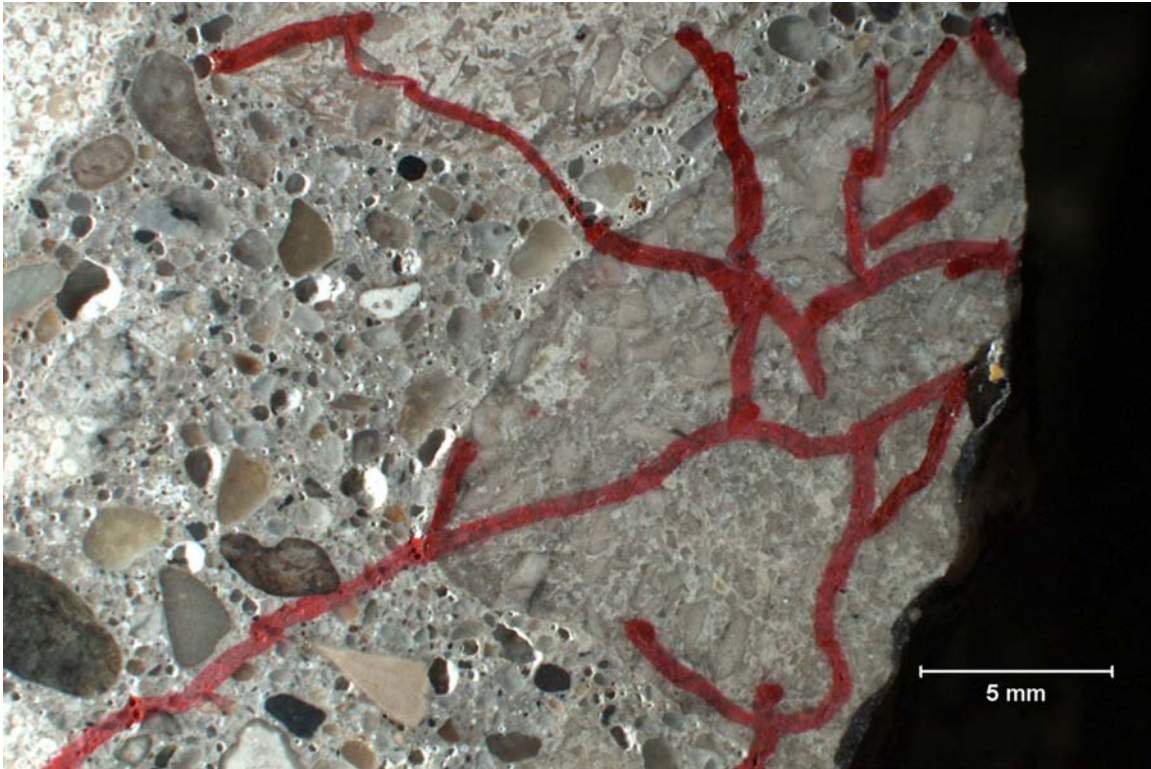
PHOTO: 21

SAMPLE ID: #2 **DESCRIPTION:** Microcracking, mapped in red ink, appears to concentrate within a coarse aggregate particle at the distressed joint plane.
MAG: 5x

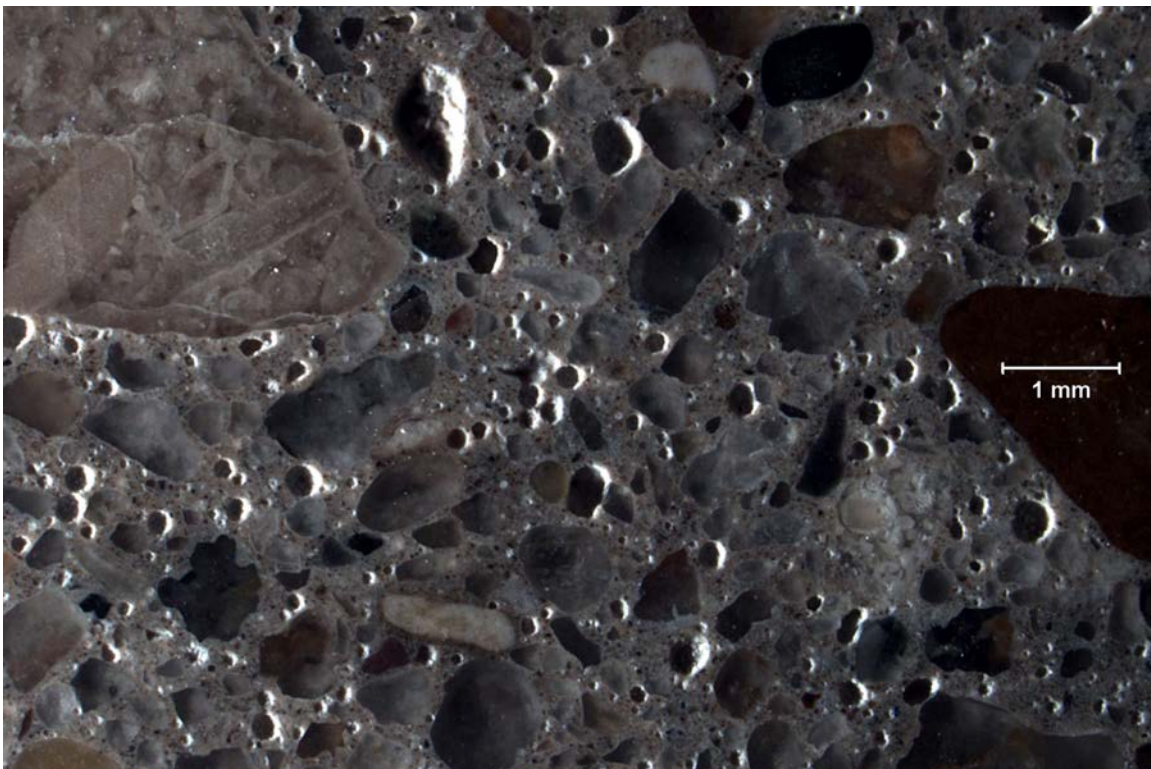
PHOTO: 22

SAMPLE ID: #2 **DESCRIPTION:** Overall hardened air void content proximate to the top surface.
MAG: 15x

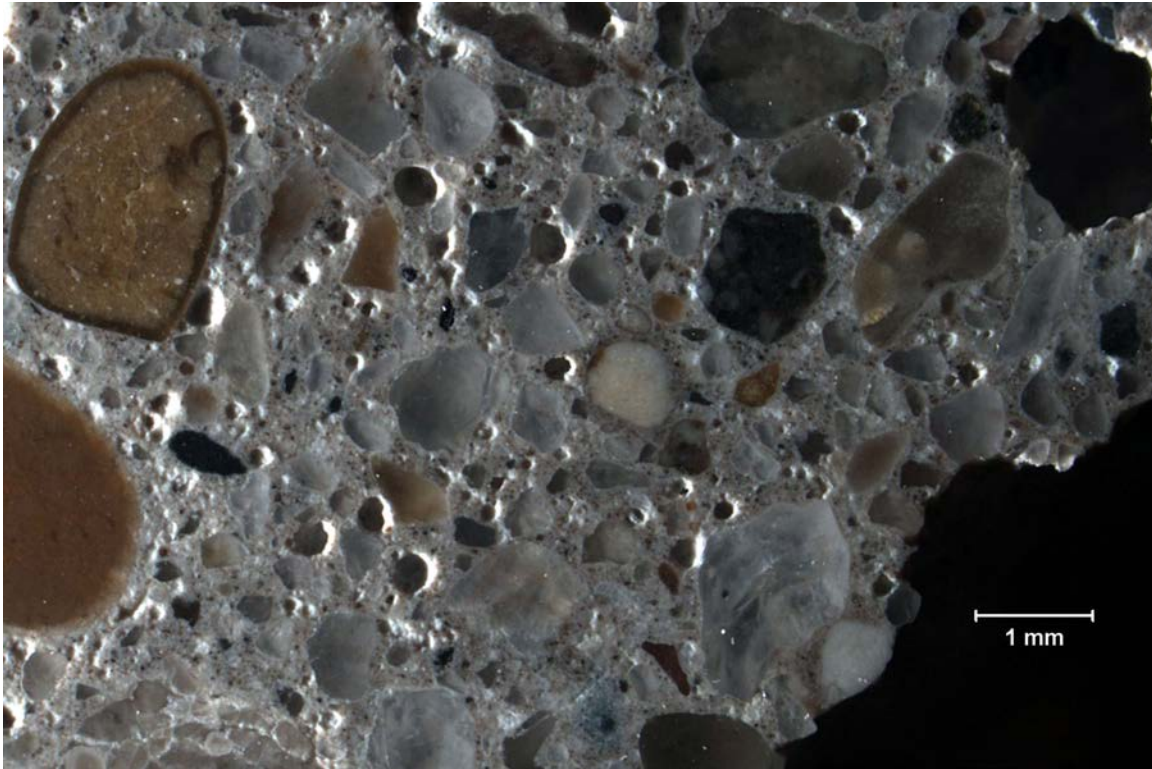
SAMPLE ID: #2 **DESCRIPTION:** Much of the finer air voidspaces in the concrete paste, proximate to the joint distress and at 55mm depth in the core, are filled with secondary ettringite

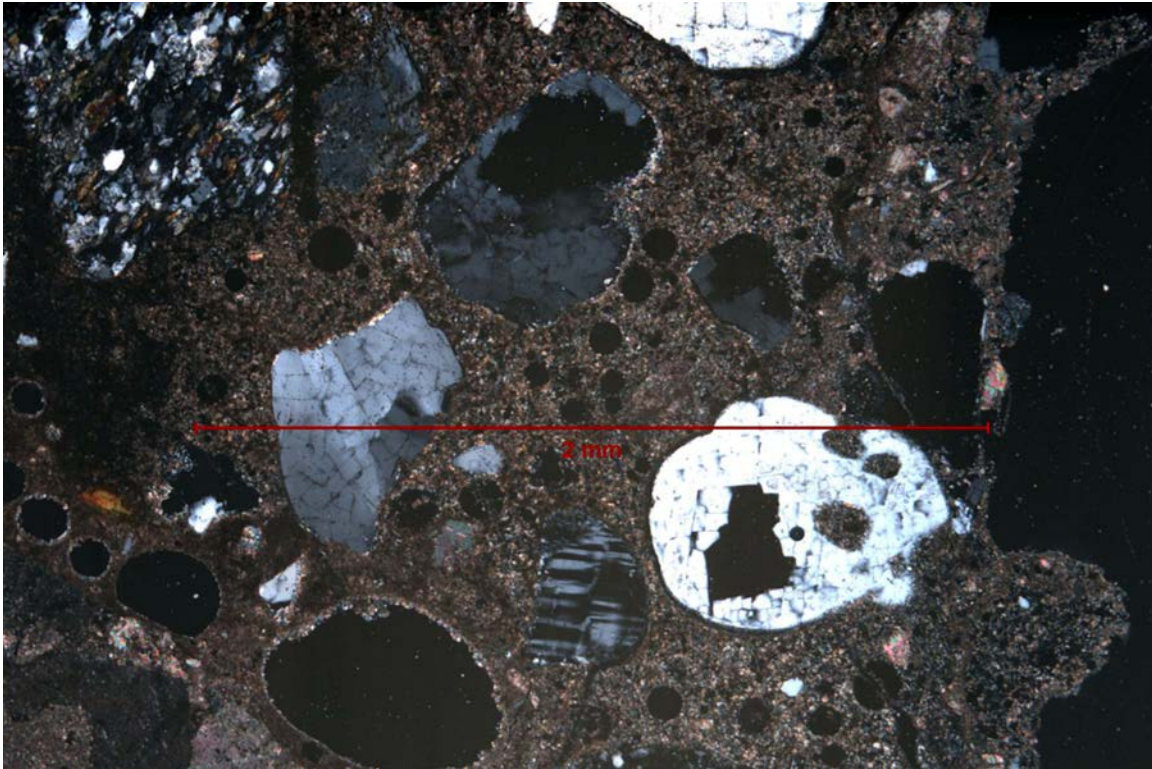
PHOTO: 25

SAMPLE ID: #2 **DESCRIPTION:** Brightly colored, carbonated concrete paste to 2mm depth from the joint distress plane (right); in thin section of concrete under cross polarized light.

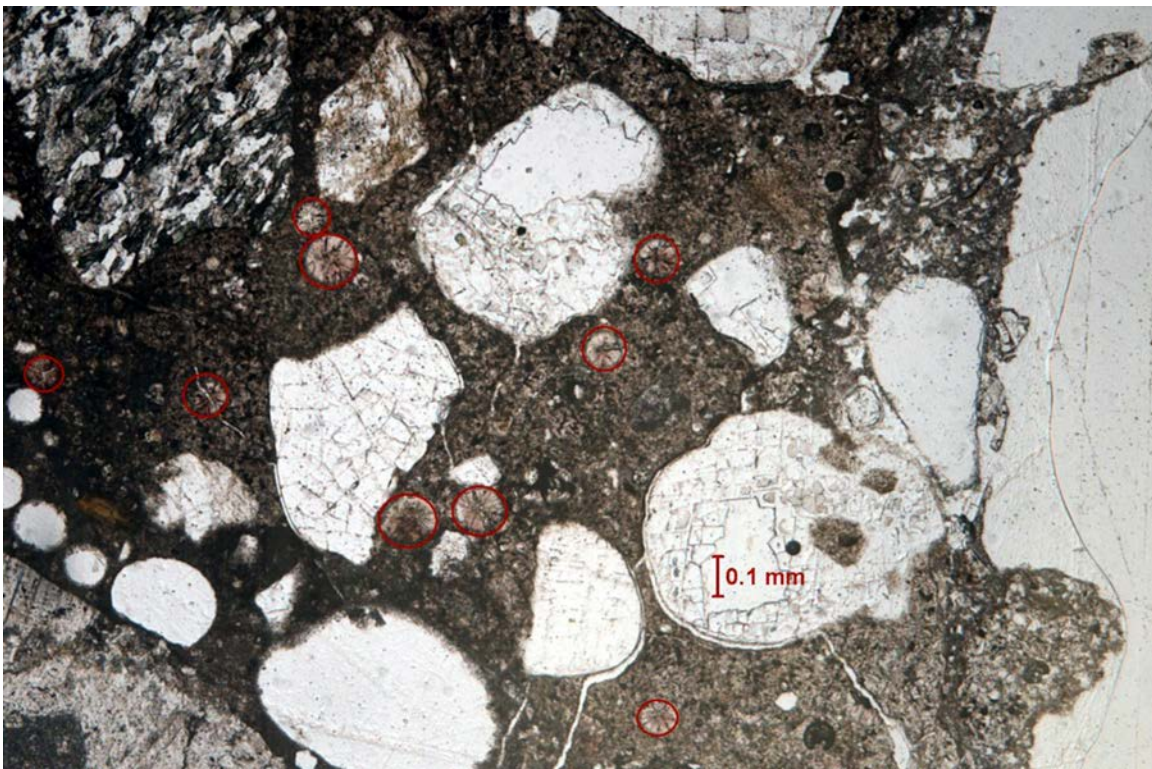
SAMPLE ID: #2 **DESCRIPTION:** Much of the air voids proximate to the joint are filled with secondary ettringite; outlined in red in thin thin section under plane polarized light.

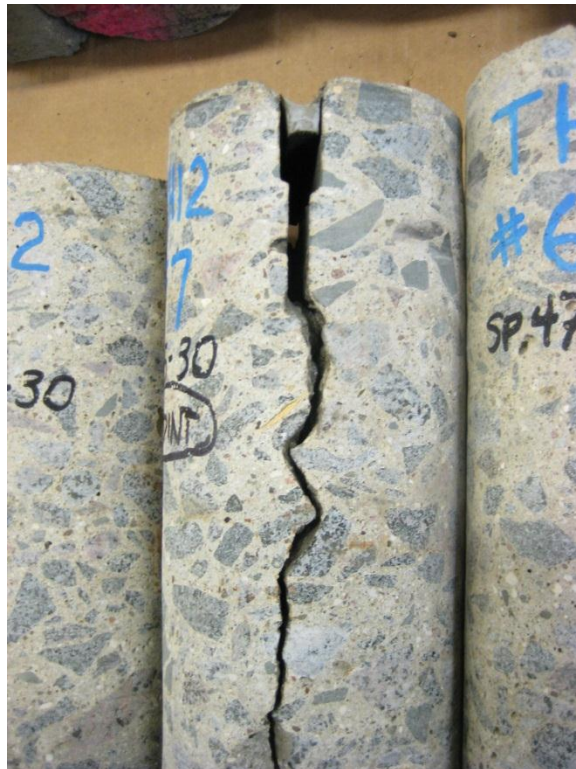
Figure 2. 4705-30 Core 7

Two cores were taken from Route 12 west of Minneapolis. One, labeled 4 (Figure 1), was selected as representing a distressed joint, while the other, labeled 7, appeared to be in better condition (Figure 2).

- The silicone sealant in both joints was de-bonded from the concrete
- Both joints were cracked out
- Damage in Core 7 was extensive but some damage was observed in Core 4
- Cracking is typical of freeze-thaw distress
- Both cores exhibited air voids filled with ettringite and the depth of ettringite-filled voids is greater in Core 4, indicating greater permeability in this core
- Carbonation is slightly deeper in Core 4 than Core 7, also indicating greater permeability
- The air void parameters are shown in Table 1
- Both samples contained 15-25% fly ash
- Top surface of both cores was in good condition

4. Core "7" was centered and taken directly through a silicone sealed (with backer rod), sawcut control joint. The top surface of the core exhibited minor mortar erosion. The silicone sealant was mostly de-bonded on both sides of the joint and the sawcuts were in relatively pristine condition; apart from "rounding" and wear of the top surface edges. In general, apart from the very thin top few millimeters (meniscus) of the silicone, the joint sealant mostly "cleanly" de-bonded from the sawcut and the vertical surfaces of the sealant in contact with the concrete are darkly stained. The distress in core "7" was characterized by mass lost along the entire depth of the resulting joint crack; with the greatest loss of 10mm to 20mm between approx. 95mm and 182mm depth in the core. Some incipient distress (sub-vertical microcracking) was observed between 115mm and 135mm depth in the joint. The concrete was purposefully air entrained and originally contained a well-distributed air void system considered freeze-thaw resistant under severe

exposure conditions. Original measured air void parameters include a 4.3% entrained-sized void volume and a 0.007" spacing factor. Secondary ettringite, with some portlandite, fills most of the smaller entrained sized voidspaces within approx. 20mm of the joint plane/surface. Void fillings decrease with depth from the joint plane. Actual measured air void parameters, which excludes the ettringite void fillings, in a band between approx. 0mm and at least 20mm (0-0.75") depth from the joint surface (below 57mm depth in the core), are 2.5% entrained volume and a 0.013" spacing factor.
